TODD LAKE DAM

NH 00288

PHASE I INSPECTION REPORT
NATIONAL DAM INSPECTION PROGRAM

AUGUST 1978

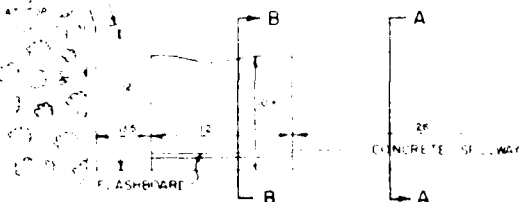
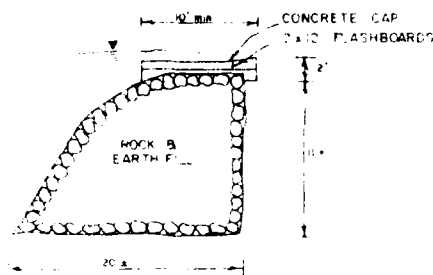
FIG. 2

PLAN OF DAM AND OLD MILL

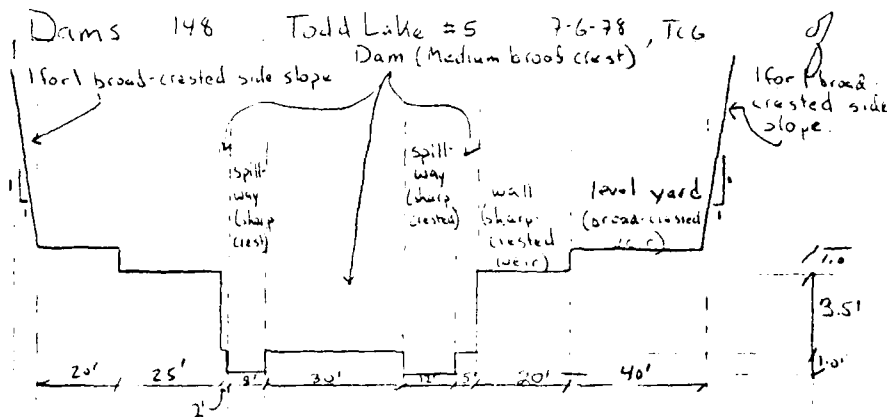
Elevation of Todd Lake Dam.

Since flow depends only on length and weir type, we could replace that dam with this "equivalent structure" and get the same stage-Discharge relationship.

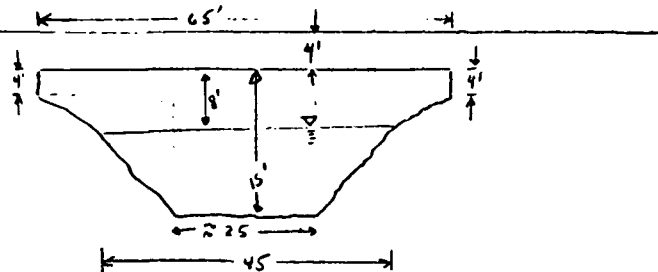
SOME CONSIDERATION MUST BE GIVEN TO WHETHER OR NOT THE NEW RITE 103 HIGHWAY EMBANKMENT WHICH FOLLOWS THE ALIGNMENT OF THE OLD RAILROAD WILL SERVE AS A DAM AND THIS REDUCE THE PEAK FLOW THAT REACHES THE TODD LAKE DAM. A CROSS SECTION AT THE HIGHWAY BRIDGE WAS TAKEN ON 7/12/78.

GIVEN THE LARGE OPENING $\approx 750 \text{ FT}^2$ AND THE LIMITED FREEBOARD OVER THE BRIDGE GOING TO PRESSURE FLOW, IT IS UNLIKELY THAT A SIGNIFICANT REDUCTION IN FLOW WOULD RESULT FROM THE BRIDGE.
